Inspection Report
Minerals Regulatory Program
Date: January 13, 2010

Mine Name: Barneys Canyon	Permit Number: M/035/0009
Operator Name: Kennecott Utah Copper	Inspection Date: December 2, 2009
Inspector(s): L Heppler, E. Berry	Time: 8:00 am
Other Participants: G. Eurick, Z. Kenyon & others- Kennecott	Mine Status: Active

Purpose of Inspection: Routine annual Inspection. This site was last inspected as a Large mine site on 12-20-2005

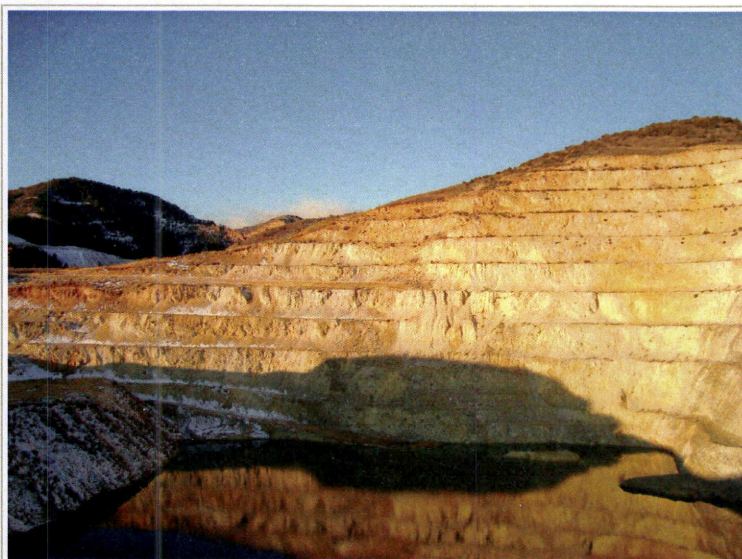
Barneys Canyon Highwall – Note reclamation on benches

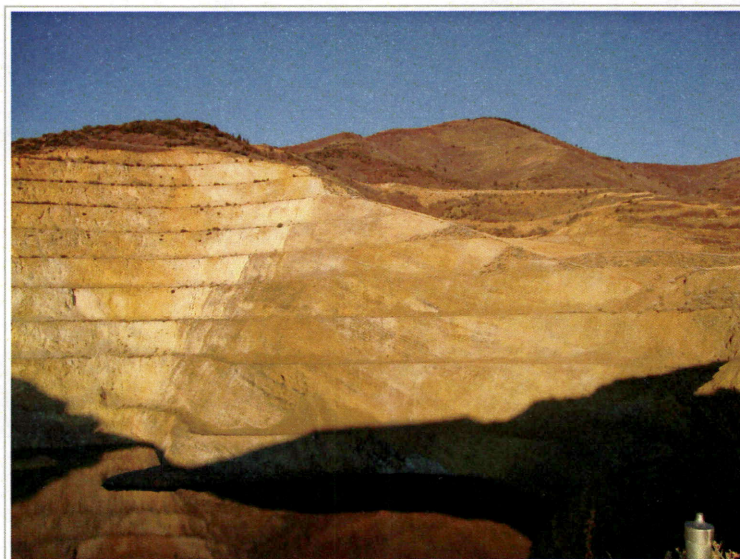
Barneys Canyon Highwall – Note reclamation on benches

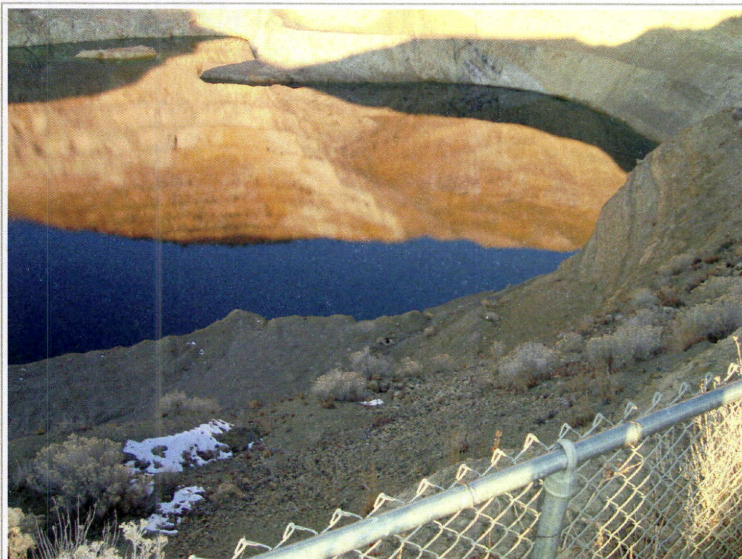
Lake Barney – Note dewatering well

Conclusions and Recommendations: OGM would like to review details on the Barneys Canyon Dewatering hole abandonment. OGM to continue annual inspections and monitor the site when in the area.

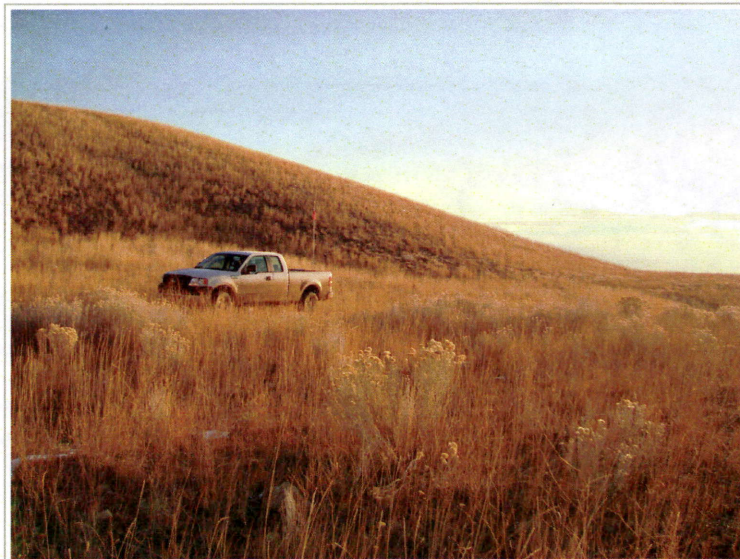
Reclamation – Reggraded and seeded

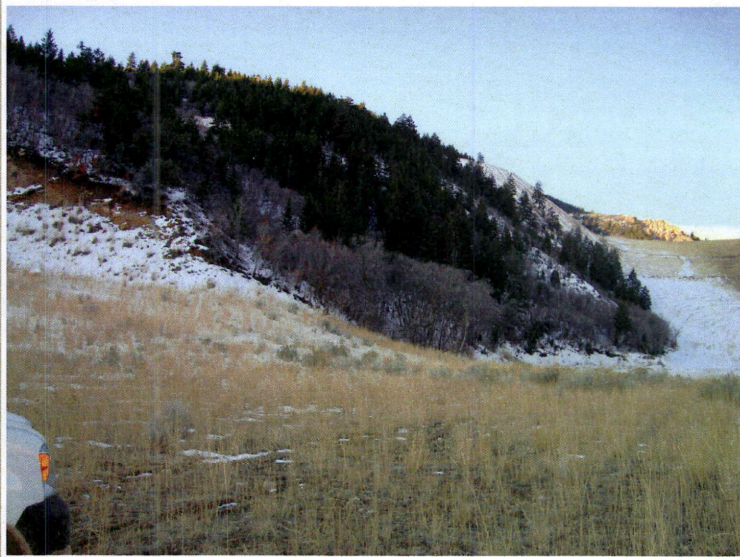
Reclaimed Melco Haul road

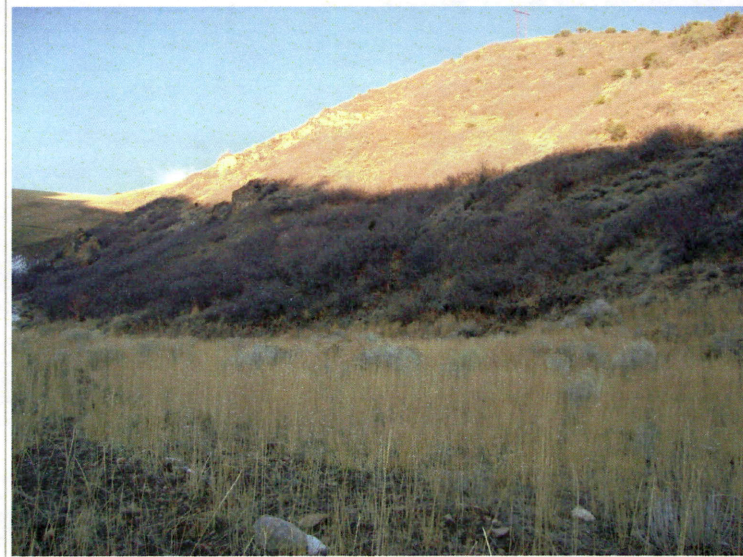
Reclaimed Melco Haul road

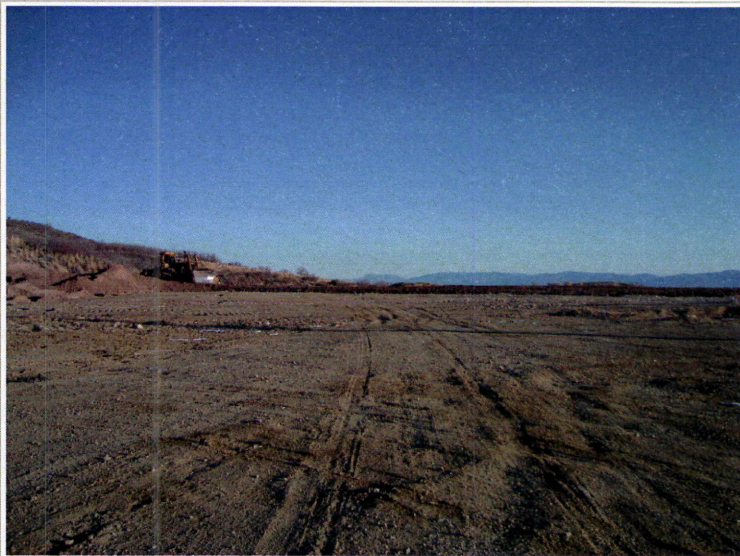
Site of Truck shop – demo complete, spreading topsoil

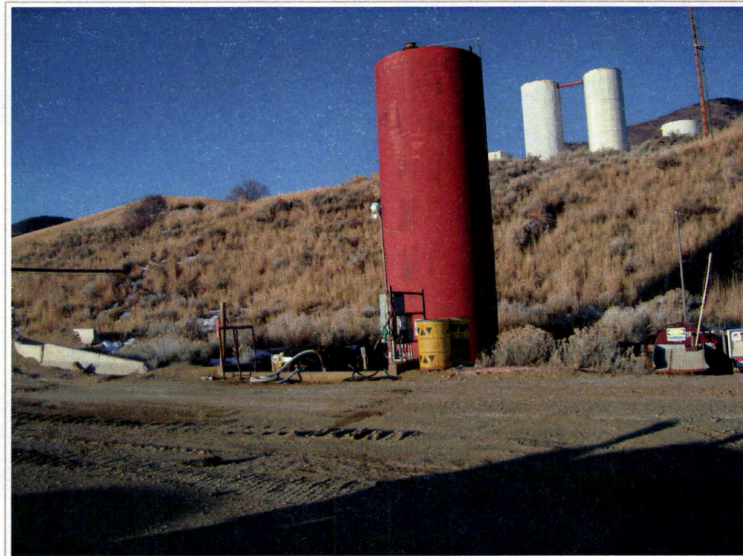
Fuel and water tanks

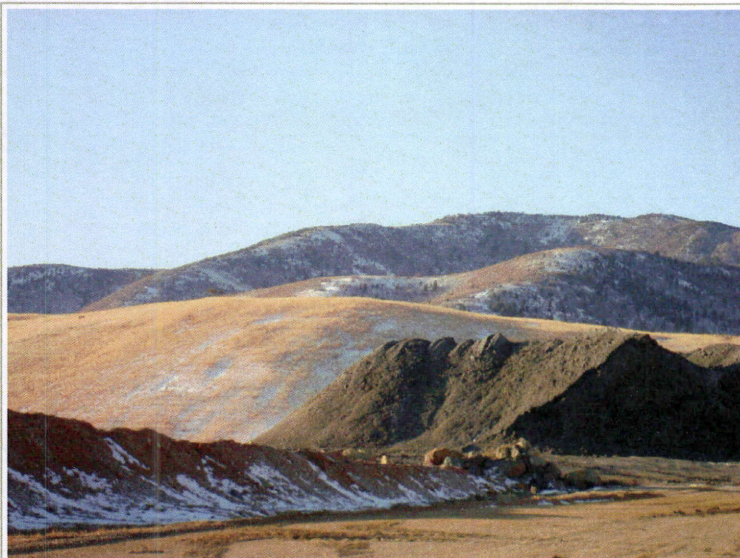
Reclaimed 6300 dump (background) & sulphide ore (foreground) mixed for Flux at Bingham

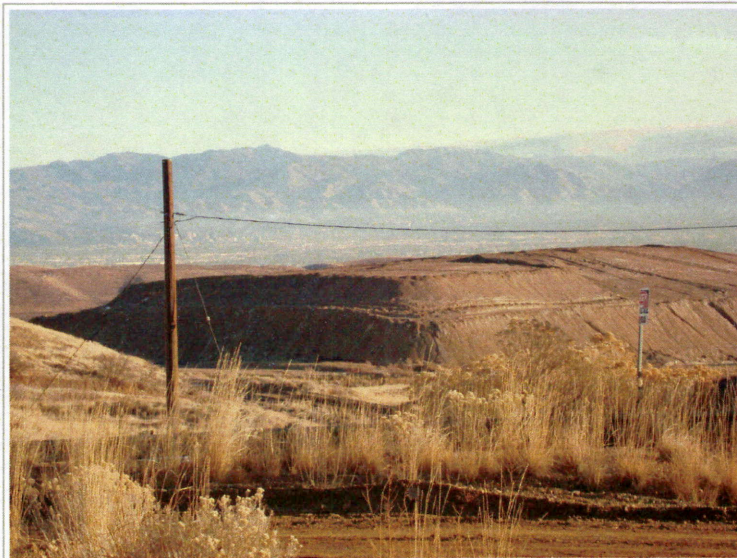
Leach pad with edges pushed down to aid leaching
